Manhole Inspection Summary

Manhole # S09CC2018MH

Insp Date: **7/31/06 10:03 AM**

Location Address: **5800 WESTERN RUN DRIVE**

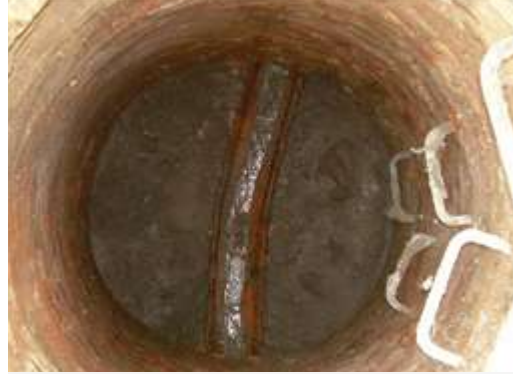
Top View

Evidence of surcharge - Bench debris.
Channel debris.

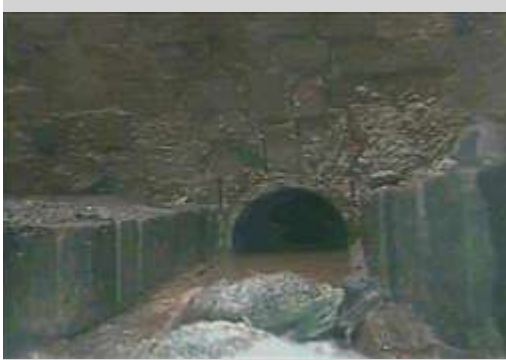
Defect

Barrel deterioration and infiltration.
Channel deterioration.

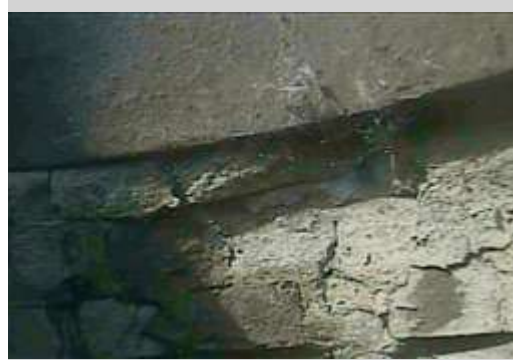
Defect

Adjustment deterioration and infiltration.

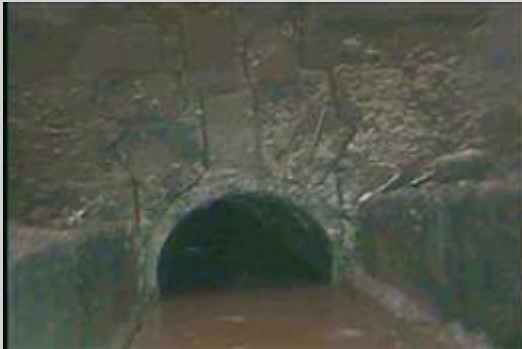
8 in. Circular Gravity Sewer Pipe Out @ 12 O'Clock

Deposits: ☐ None ☐ Mud ☐ Sludge ☒ **Debris** ☐ Grease

Silt Depth: **1** (in.) Deposits Extent: **Light**

Infiltration: **Evidence** Pipe Seal Cond: **Unknown**

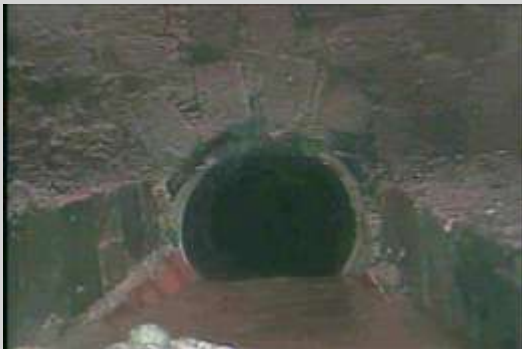
8 in. Circular Gravity Sewer Pipe In @ 6 O'Clock

Infiltration: **Evidence** Pipe Seal Cond: **Broken**
